# **INDOOR AIR QUALITY ASSESSMENT**

**Helen Mae Sauter Elementary School  
130 Elm Street  
Gardner, Massachusetts**

Prepared by:  
Massachusetts Department of Public Health  
Center for Environmental Health  
Emergency Response/Indoor Air Quality Program  
August 2006

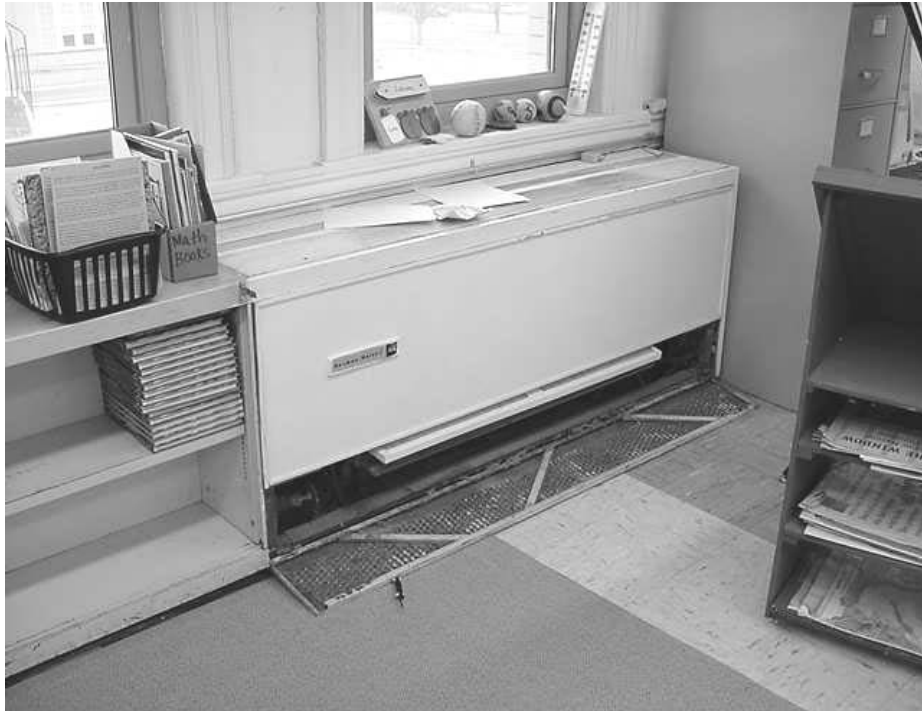
**Picture 1**

Fresh air in classrooms is supplied by a unit ventilator (univent) system ([Figure 1](#)). Univents draw air from outdoors through a fresh air intake located on the exterior walls of the building (Picture 1) and return air through an air intake located at the base of each unit. Fresh and return air are mixed, filtered, heated or cooled and provided to classrooms through an air diffuser located in the top of the unit. Univents have control settings of off, low or high. Adjustable louvers control the ratio of outside to recirculated air. Obstructions to airflow, such as items stored on or in front of univents were seen in some areas. In order for univents to provide fresh air as designed, units must be activated while rooms are occupied and air diffusers should remain free of obstructions.

**Univent**

5. Remove all blockages from univents to ensure adequate airflow.
6. Consider adopting a balancing schedule of every 5 years for mechanical ventilation systems, as recommended by ventilation industrial standards (SMACNA, 1994).

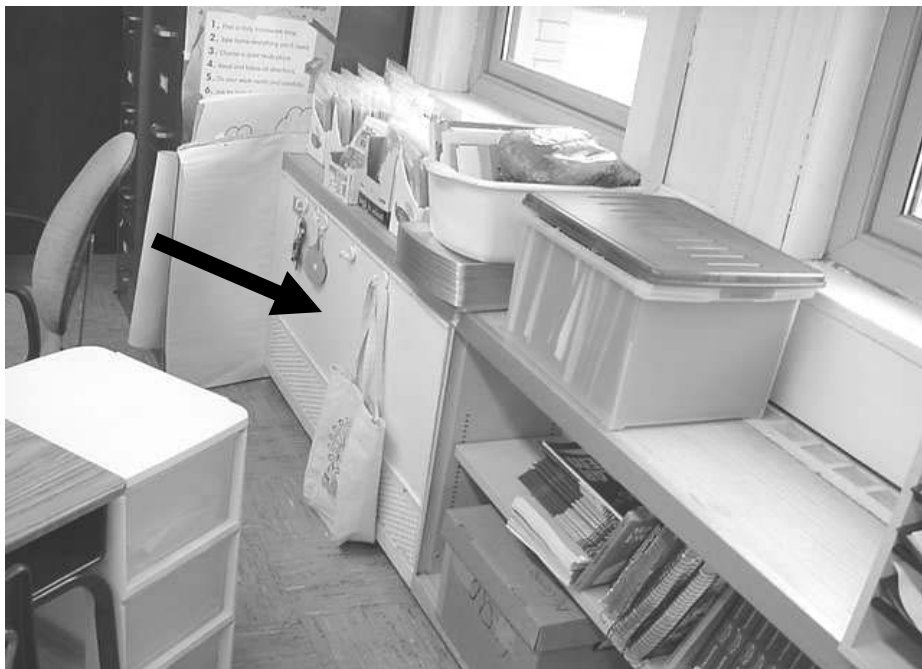
**Picture 2**

Exhaust ventilation on the lower floor is provided by unit exhaust vents (UEVs) (Picture 2). This equipment contains two fans that draw air from the building, several of which were not operating during the assessment. Without functional mechanical fresh air supply or exhaust ventilation, environmental pollutants can accumulate within the building and lead to air quality/comfort complaints.

**Unit Exhaust Ventilator**

4. Operate all ventilation systems throughout the building (e.g., gym, auditorium, classrooms) continuously during periods of school occupancy independent of thermostat control to maximize air exchange. To increase airflow in classrooms, set univent controls to “high”.

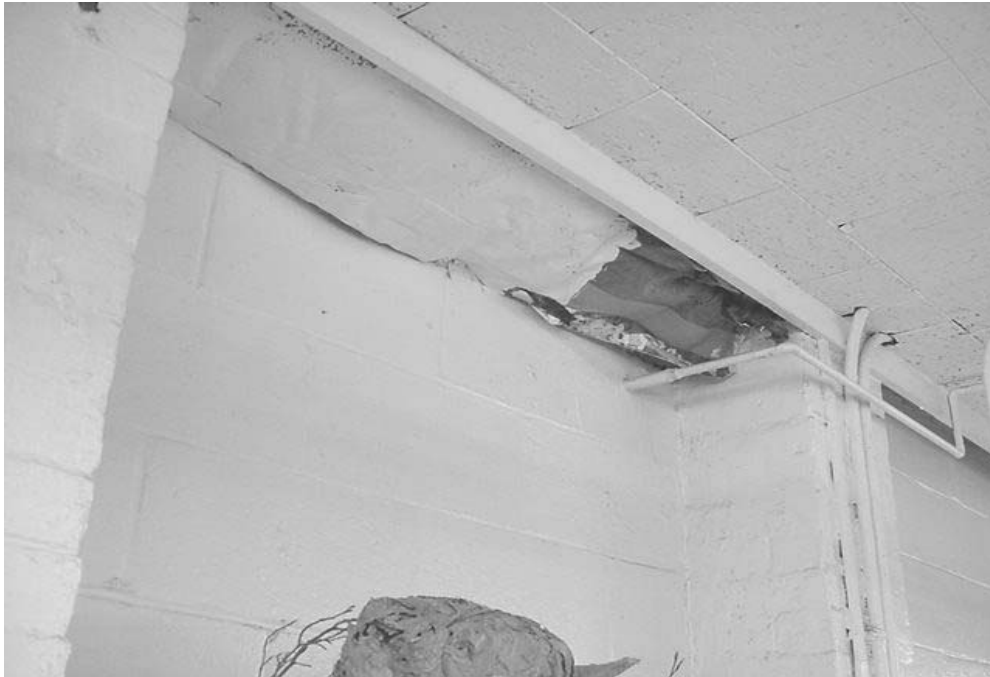
**Picture 3**

Several areas had water-stained ceiling tiles, which can indicate leaks from the roof or plumbing system. Of note is the library and office suite of rooms containing the guidance and speech programs on the third floor (Picture 3), both of which had walls that are covered with acoustic tile that were water damaged. The water damage to the acoustic wall tiles appears to be related to a historic leak that originated in the attic above this area. CEH staff were in the HMSES during a two hour, wind-driven rainstorm [measured wind gust up to 60 MPH (Weather Underground, 2006)]. CEH staff examined the attic after this rainstorm and did not observe any active leaks. Water-damaged ceiling and acoustic wall tiles can provide a source for mold and should be replaced after a water leak is discovered and repaired. A number of areas around the basement exterior wall showed signs of water damage (Picture 4) or efflorescence (Picture 5). Efflorescence is caused by water penetration through brick, dissolving minerals within the brick as it flows through. The water evaporates leaving a dry white residue. While efflorescence is a characteristic sign of water penetration, it is not mold growth. The presence of efflorescence can indicate that water is penetrating through the exterior wall system.

**Water Damaged Ceiling Tile and Insulation, Basement Library**

1. Remove water damaged ceiling and acoustic wall tiles . This measure will remove actively growing mold colonies that may be present. Remove mold contaminated materials in a manner consistent with recommendations in “Mold Remediation in Schools and Commercial Buildings” published by the US Environmental Protection Agency (US EPA, 2001). Copies of this document can be downloaded from the US EPA website at: [http://www.epa.gov/iaq/molds/mold\\_remediation.html](http://www.epa.gov/iaq/molds/mold_remediation.html).
2. Examine the feasibility of installing a gutter/downspout system for the roof to prevent excess water exposure to the exterior wall. Ensure that the downspout drains water at a point that is at least 5 feet away from the exterior wall of the building.

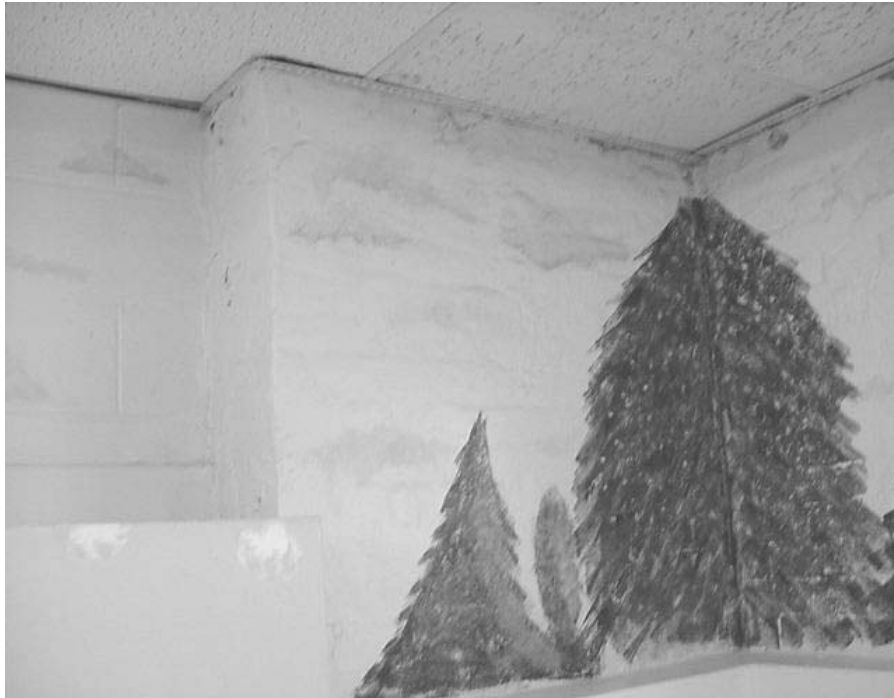
**Picture 5**

**Efflorescence and Water Damaged Ceiling Tiles, Basement Cafeteria**

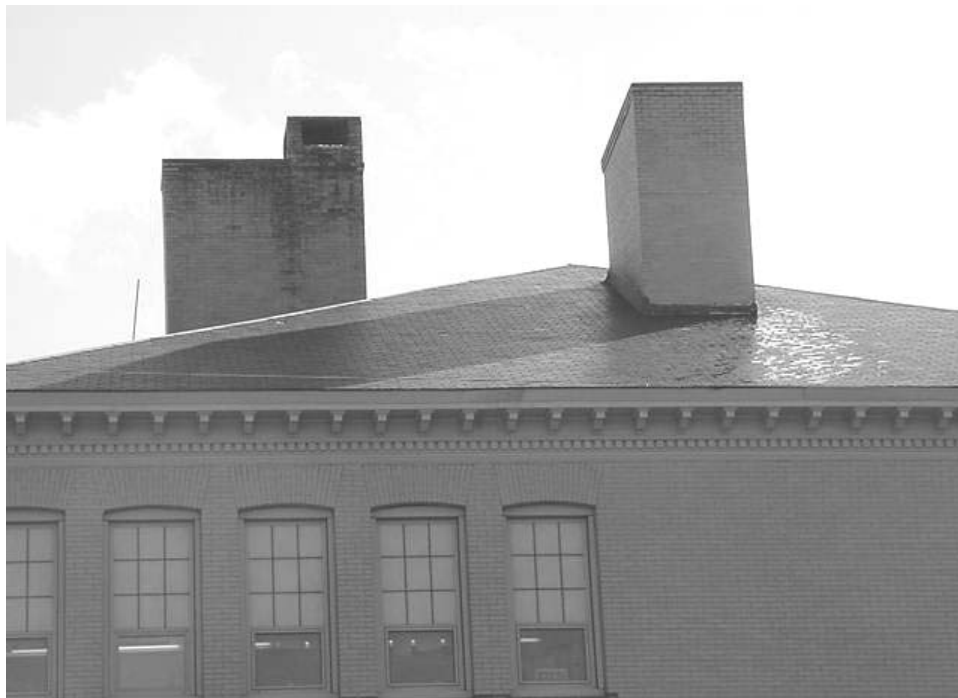
**Picture 6**

Water damaged tiles in the basement may be related to pooling/splashing water at the base of the building. The roof edge does not appear to have a gutter/downspout system (Picture 6). Rainwater pours off the roof, which then impacts on the tarmac at the base of the building, allowing for the foundation wall, plugs in former windows frames (Picture 7) and window systems to become moistened during rain. Rainwater should be drained from the roof and be directed away from the building in order to prevent water penetration through the foundation.

**Roof Edge without Gutter**

3. Take steps to prevent prolonged moisture contact with the foundation. These steps may include:
  - a. Removing foliage, gardens and mulch to at least five feet away from the foundation.

- b. Improving the grading of the ground away from the foundation at a rate of 6 inches per every 10 feet (Lstiburek, & Brennan, 2001).
  - c. Installing a water impermeable layer on ground surface (clay cap) to prevent water saturation of ground near foundation (Lstiburek, & Brennan, 2001).

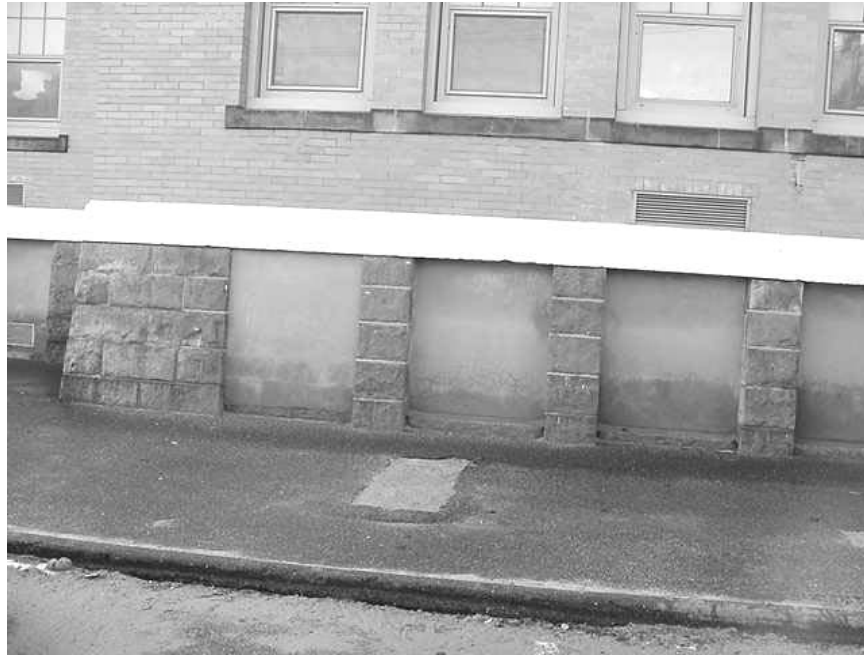
**Picture 7**

**Wetting of Foundation and Windows by Splashing Rainwater**

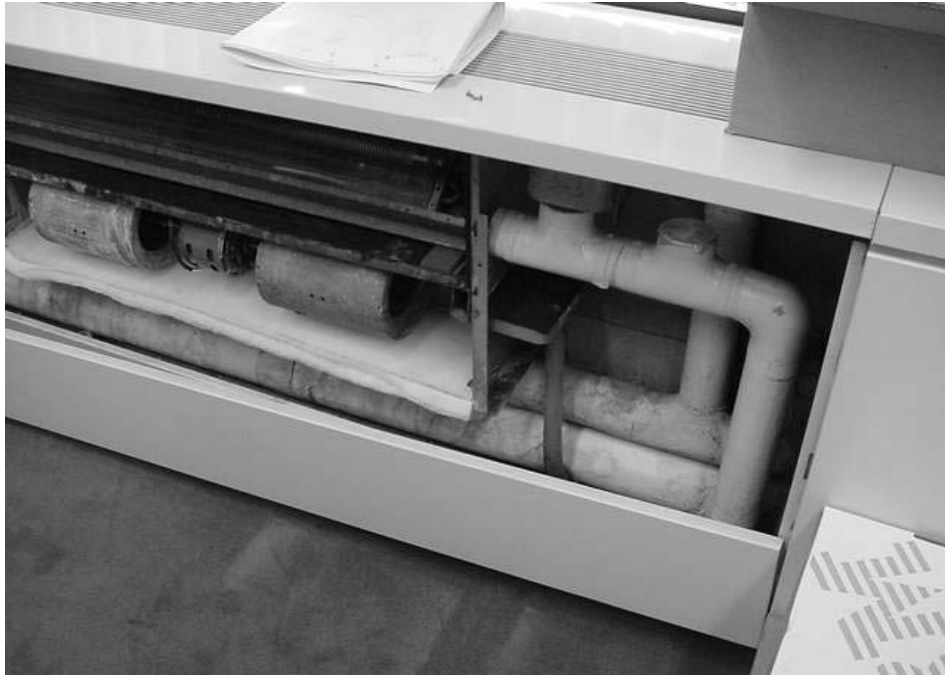
**Picture 9**

Univents are outfitted with a filter that strains particulates from airflow. Filters were cut from filter media and installed in each univent (Picture 9). Spaces were observed between the filter medium and the cabinet wall, which can result in air bypassing filters. In addition, holes were found in the cabinet above the filters, which can allow for unfiltered air and particles to bypass the filter (Picture 10). In this condition dust, dirt and other debris can then be re-aerosolized by the ventilation system. In order to decrease aerosolized particulates, disposable filters with an increased dust spot efficiency can be installed.

**Filter Media Cut To Fit Univent**

7. Change filters for air-handling equipment as per the manufacturer’s instructions or more frequently if needed. Vacuum interior of units prior to activation to prevent the aerosolization of dirt, dust and particulates. Ensure filters fit flush in their racks with no spaces in between allowing bypass of unfiltered air into the unit.

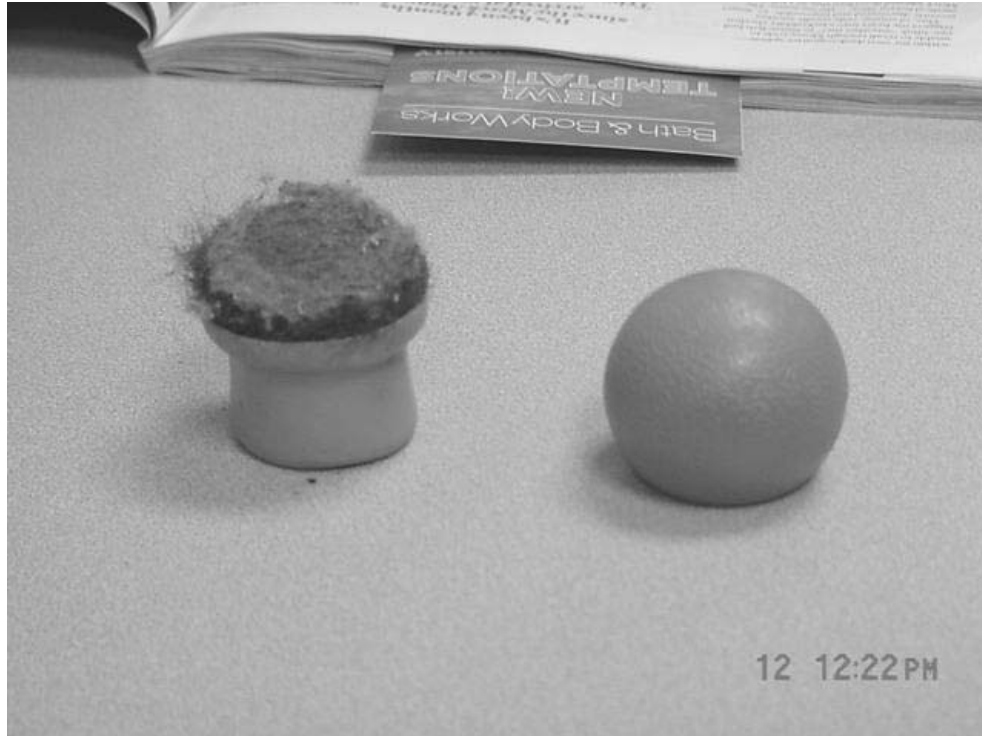
**Picture 11**

**“Glides” for Chair Legs that can be used as an Alternative to Tennis Balls**

13. Consider discontinuing the use of tennis balls on walker legs to prevent latex dust generation. Alternative “glides” can commonly be purchased from office supply stores, see Picture 11 for an example.
